Test Report

REPORT NUMBER: 4786435947-45

Item Under Test	ISO Valve components with powder coating		
Type / Model	Powder Coated Cover and Powder Coated Bonnet with a coating thickness of 300-400 microns		
Number of samples	One- Cover, One Bonnet		
Sample Identification	Model: ISO Valve Cover, sample card no. 1893281 Model: ISO Valve Bonnet, sample card no. 1893282		
Serial Number (If any)	NA		
Condition of IUT on receipt	Good		
Date of Receipt	11 June 2014		
Applicable Standard	ASTM B117 Designation: B117-11- Standard Practice for Operating Salt Spray(Fog) apparatus		
Date of Testing (Start date)	11 June 2014	End Date	14 June 2014
Lab general* ambient condition	Temperature in °C		23±5°C
	Relative humidity in %		<70%
Date of Reporting	23 June 2014		
Test In-charge	Pradeep. N

Testing of Coated ISO Valve components as per ASTM B117 Designation: B117-11-Standard Practice for Operating Salt Spray (Fog) apparatus

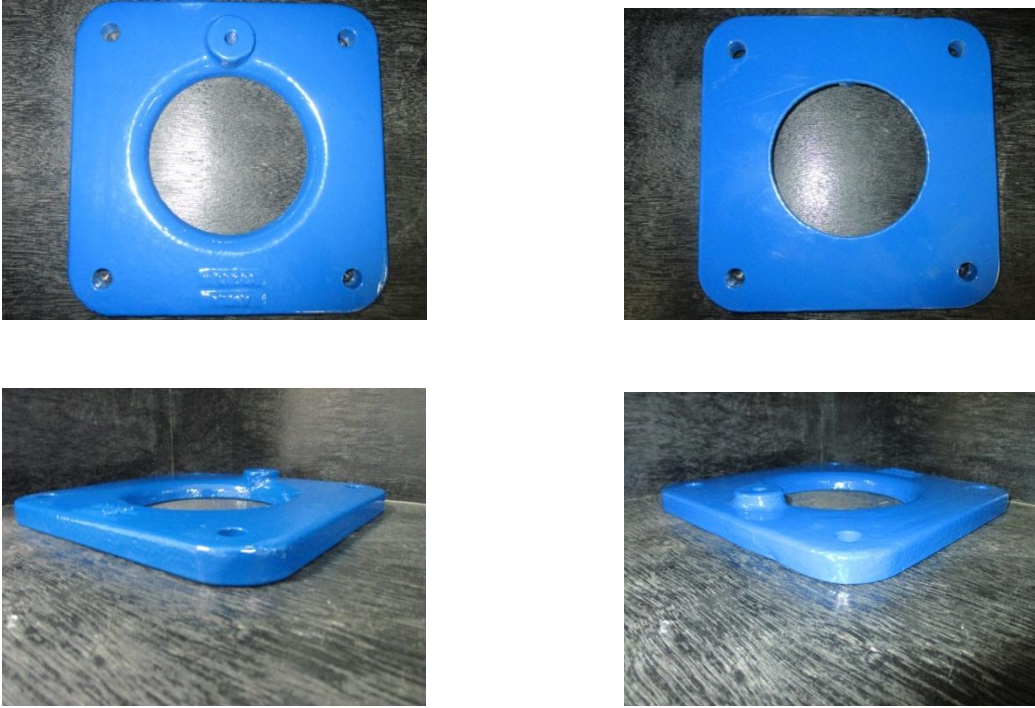
Fig 1: ISO Valve Cover (Before test)

Result –The Visual inspection before Salt mist test did not exhibit any mechanical deterioration or corrosion on samples.

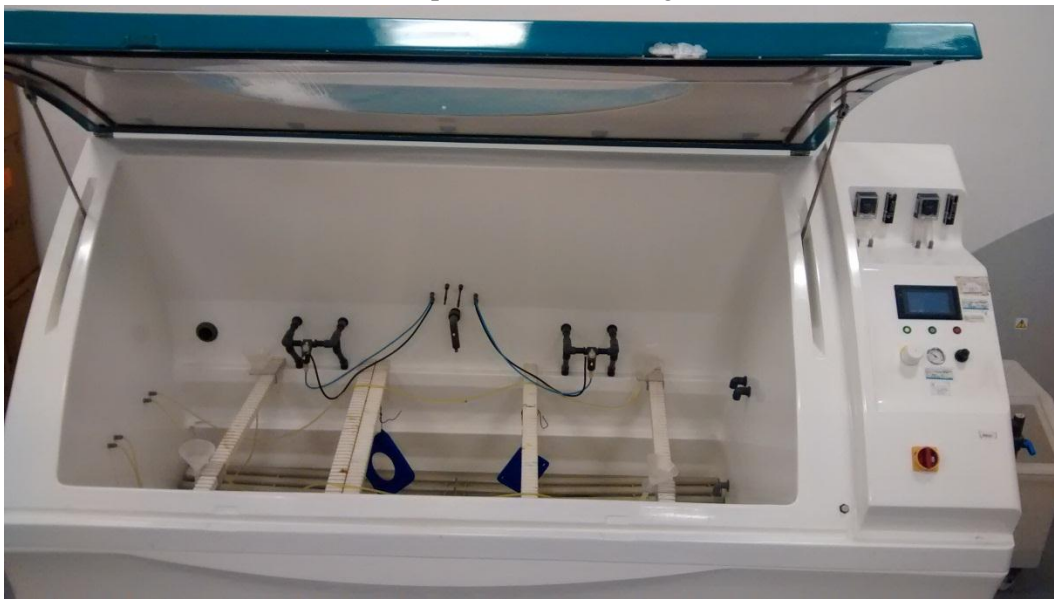
Fig 3: Test Setup

The chamber for this test was constructed of such materials that would not influence the corrosive effects of the salt mist. The detailed construction of the chamber, including the method of producing the mist is as follows:

The atomizer used was of such a design and construction as to produce a finely divided, wet, dense mist. The atomizer was made of material that is non-reactive to the salt solution.

The salt used for the test was high quality sodium chloride (NaCl) containing, when dry. The salt solution concentration shall be $5\% \pm 1\%$ by weight.

The pH value of the solution was 7.02, at a temperature of 25 ± 2 degree C.

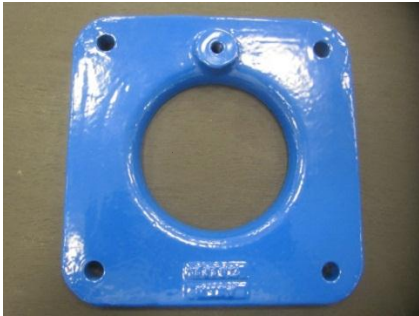
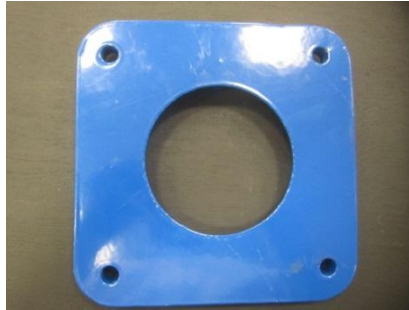
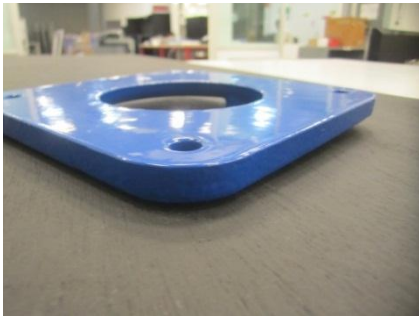
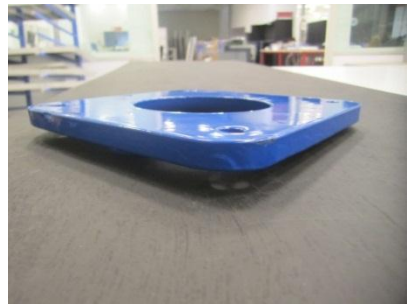
Fig 4: ISO Valve Cover (After test)

The Visual inspection after Salt mist test did not exhibit any mechanical deterioration or corrosion on solar modules.
